Article No.: TASC Tip\_02-07

## TAAT reverse issues

### Should you replace the valve body?

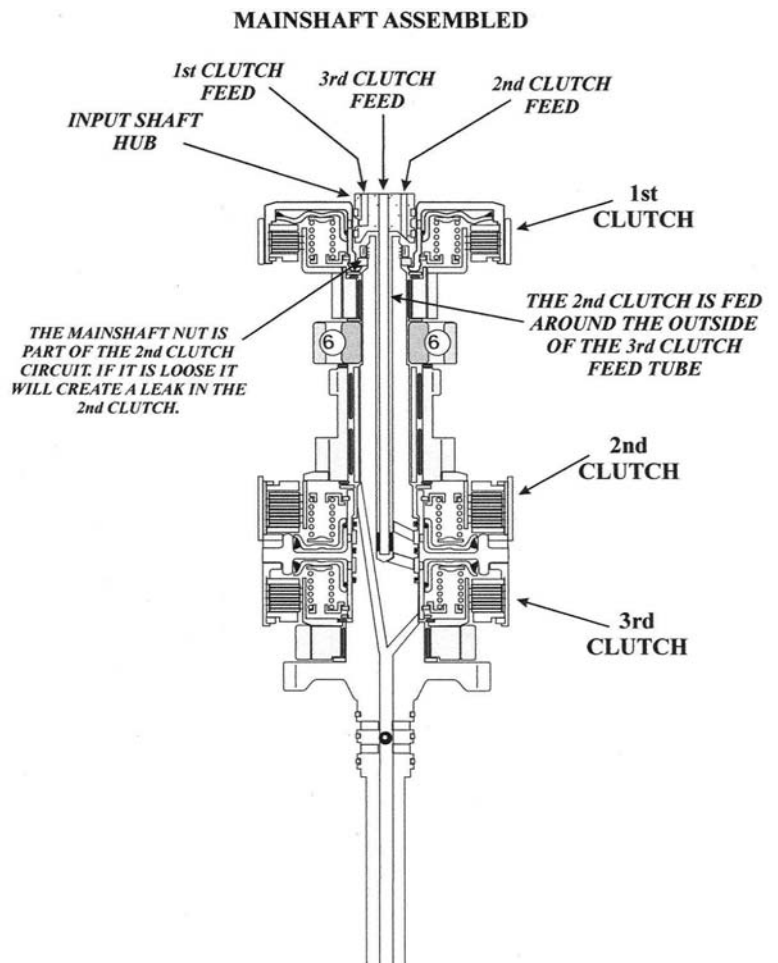
Figure 1

The most common cause of delay or no reverse, other than the valve body, is a loose mainshaft nut (see Figure 1). The symptoms will most likely occur when the vehicle is hot, and may also exhibit a soft or flared 2nd gear upshift. According to ATSG's 2003 Seminar information, a loose mainshaft nut can cause a leak in the 2nd clutch circuit. When the nut is loose, the mainshaft walks back and forth in the middle of the case. This causes a small gap between the 1st clutch and the nut, which is where the leak in the 2nd clutch circuit appears. A new mainshaft nut should be replaced with every

repair, since it has a factory thread locker. The nut can be accessed by removing the side cover, which means the unit does not have to be removed to replace it. The nut, and this is very important, should be torqued to 111 ft. lbs. The Saturn part number for the mainshaft nut is 2100680.

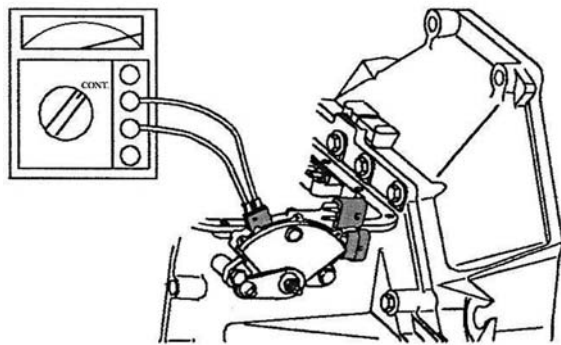
Figure 2 illustration courtesy ATSG

Another problem that occurs, especially when the unit has been removed, is an incorrectly adjusted pattern select switch, which we all commonly know as the manual lever positioning switch. If the pattern select switch is not adjusted properly, a no reverse condition, as well as loss of drive and/or erratic or harsh shifting can occur. To adjust the pattern select switch, according to the ATSG Service Information, put the selector in the D4 position. DO NOT start the vehicle. Connect an ohm meter to the switch (see Figure 2). Rotate the switch until the ohm meter reads continuity. Once a reading is obtained, tighten the pattern select switch.
