U140/U240/U241 Series Diagnostic Information

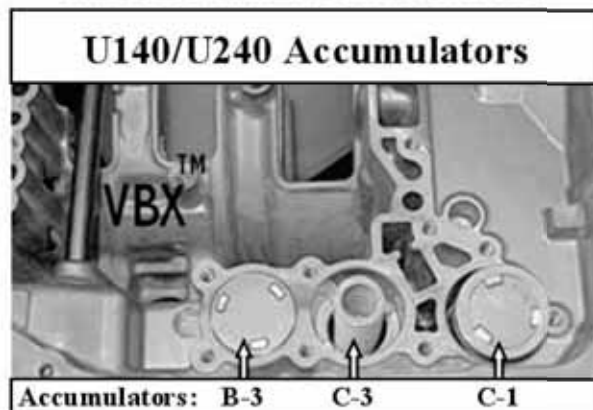
CASE ACCUMULATOR LOCATIONS

Various Shift & Engagement Feel Concerns - Can be due to accumulator spring mix up. Please see chart below for correct information.

NOTE: C1 accumulator is for N-D engagement. C3 accumulator is for 3-4 shift. B3 accumulator affects 4-3 downshift.
